# INSPECTION REPORT

For the Property at:  
**123 SAMPLE STREET**  
SAMPLEVILLE, ON

Prepared for: JOE SMITH  
Inspection Date: Saturday, March 9, 2024  
Prepared by: Graham Mathers, CAHPI C2000793

RE: Report No. 1272, v.0  
123 Sample Street  
Sampleville, ON

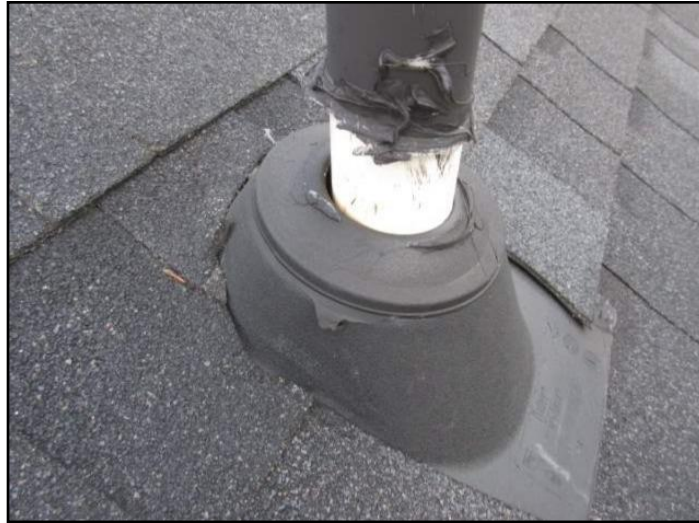
1. **Condition:** • [Leak](#)

**Implication(s):** Chance of water damage to structure, finishes and contents

**Location:** North Roof

1. *Leak*

**Task:** Correct

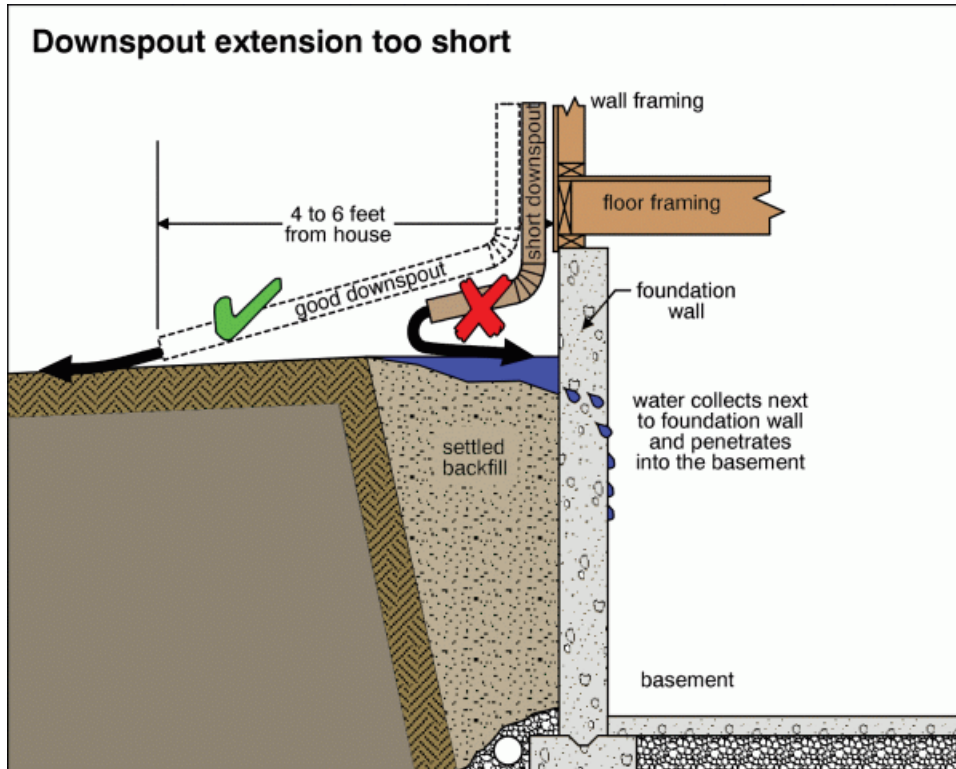
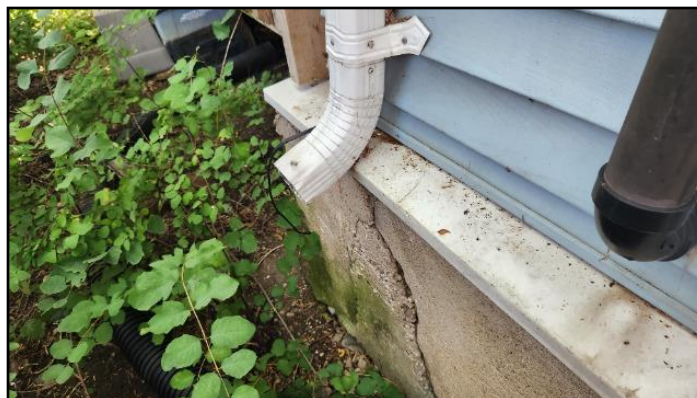
2. Condition: • [Should discharge 6 feet from building](#)

Implication(s): Chance of water damage to structure, finishes and contents

Location: West Exterior Wall

2. Should discharge 6 feet from building

Task: Correct

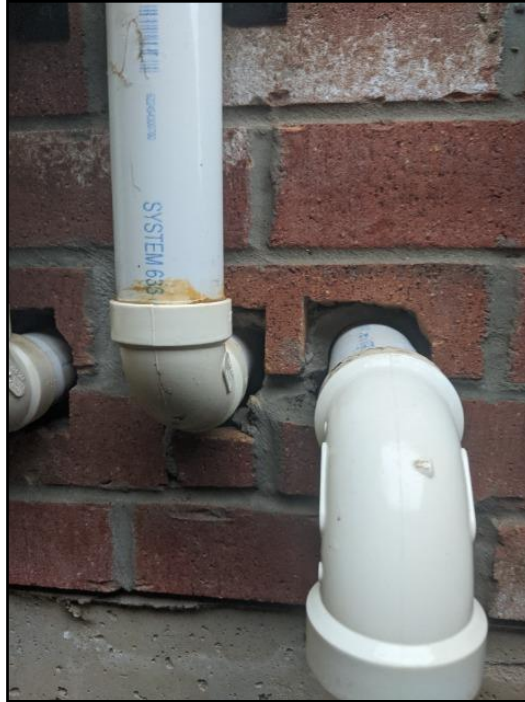
3. Condition: • [Caulking missing or ineffective](#)

**Implication(s):** Chance of water damage to structure, finishes and contents

**Location:** South Exterior Wall

3. Caulking missing or ineffective

**Task:** Correct

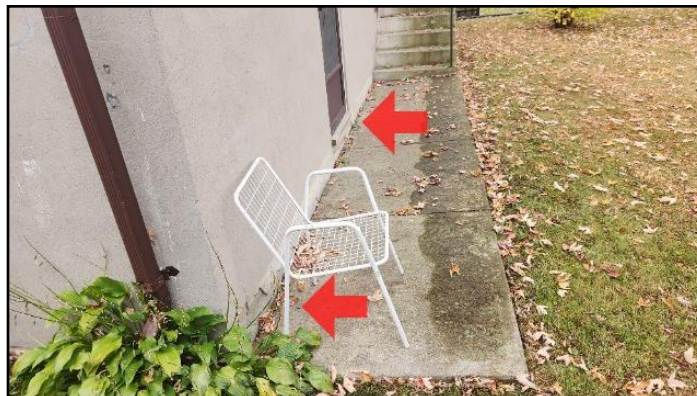
4. **Condition:** • Improper slope or drainage

**Implication(s):** Chance of water damage to structure, finishes and contents

**Location:** Rear Exterior Wall

4. Improper slope or drainage

**Task:** Correct

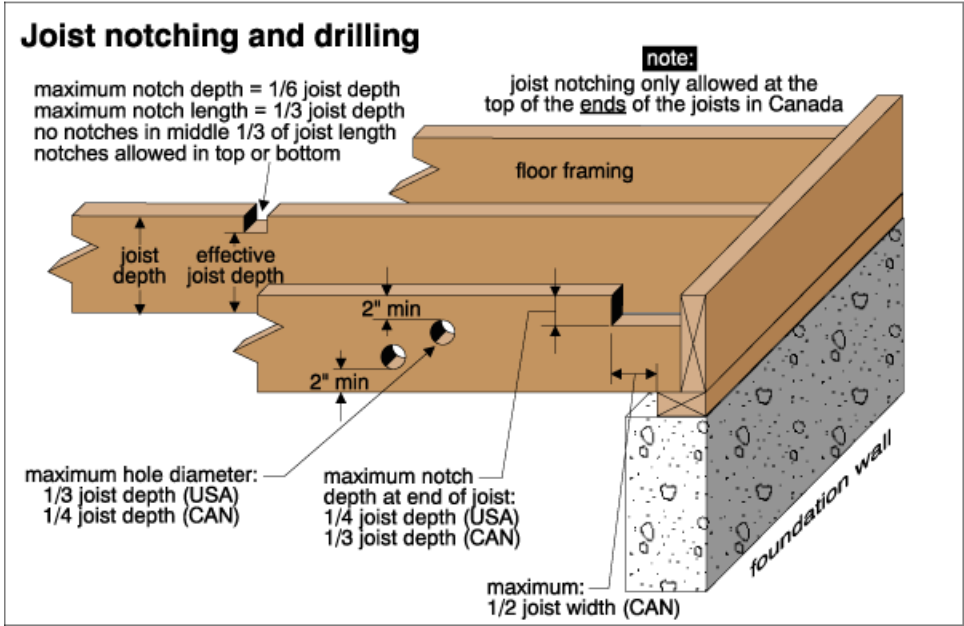
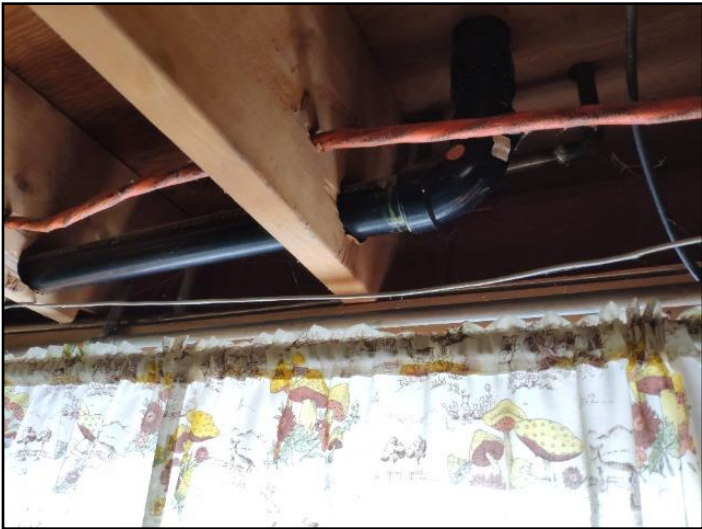
5. Condition: • [Notches or holes](#)

Implication(s): Weakened structure

Location: Basement Utility Room

6. Notches or holes

Task: Repair

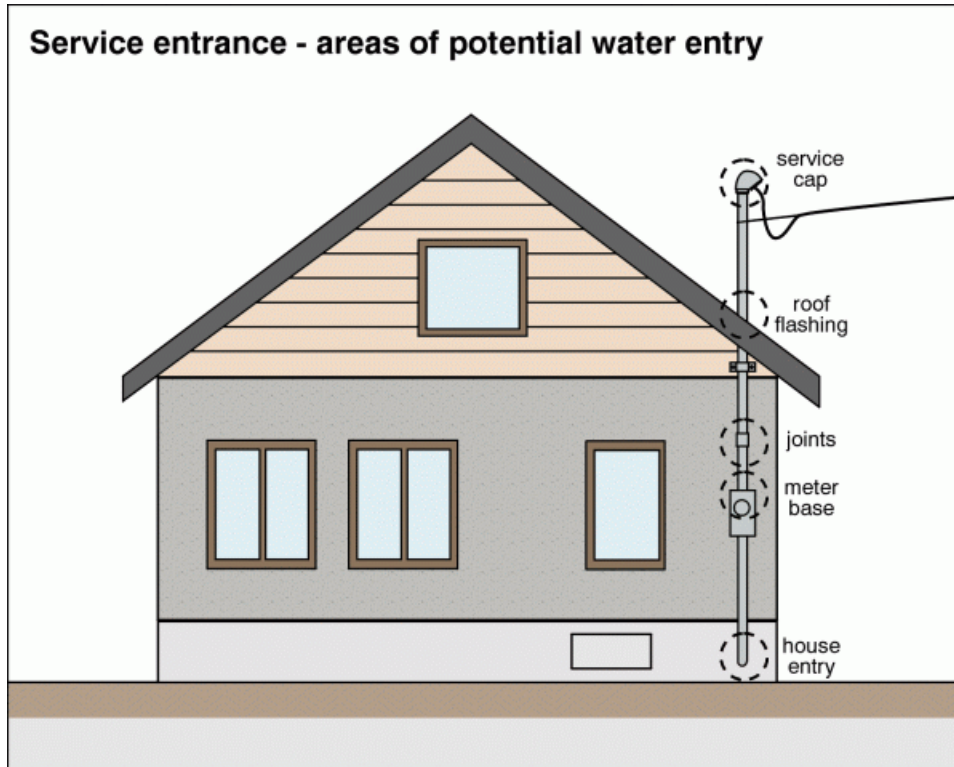
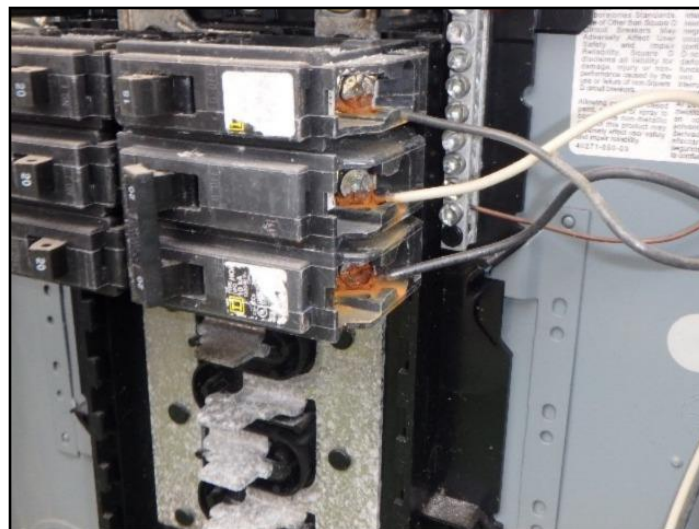
**6. Condition:** • [Rust or water in panel](#)

**Implication(s):** Fire hazard | Electric shock

**Location:** Basement

**7. Rust or water in panel**

**Task:** Repair

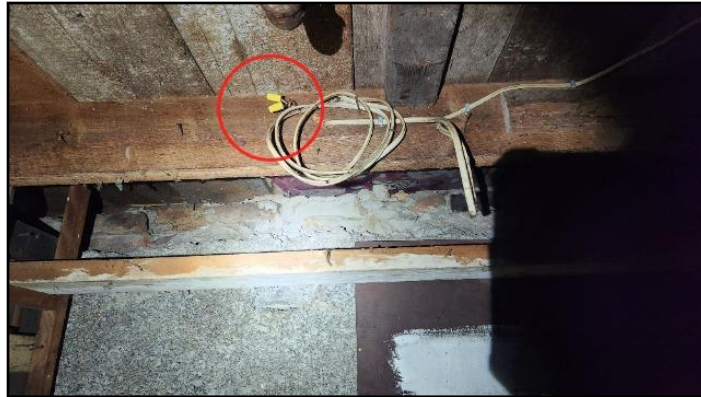
**7. Condition:** • [Missing](#)

**Implication(s):** Fire hazard | Electric shock

**Location:** Basement Utility Room

8. Missing junction box

**Task:** Provide

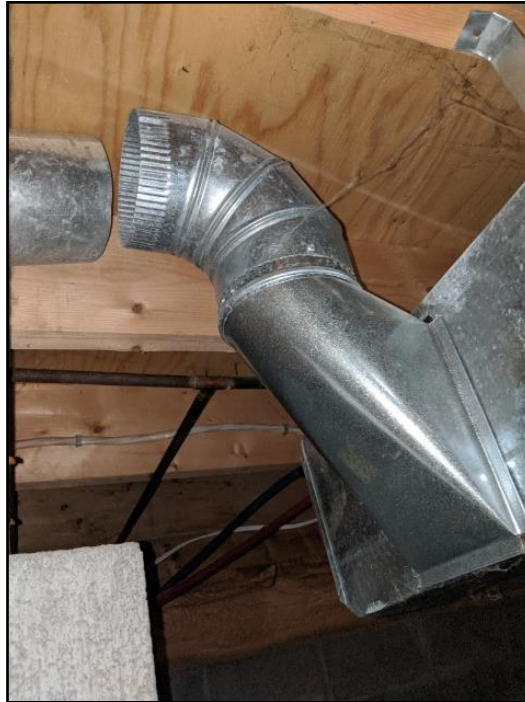
**9. Condition:** • [Disconnected ducts](#)

**Implication(s):** Increased heating costs | Reduced comfort

**Location:** Basement

11. *Disconnected ducts*

**Task:** Correct

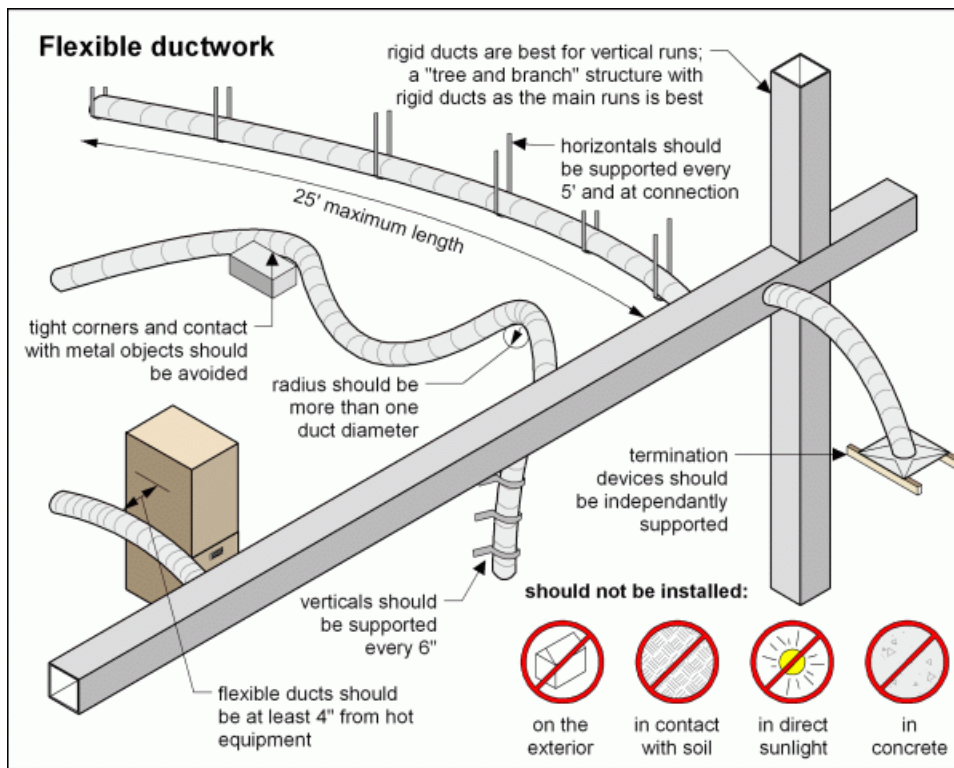
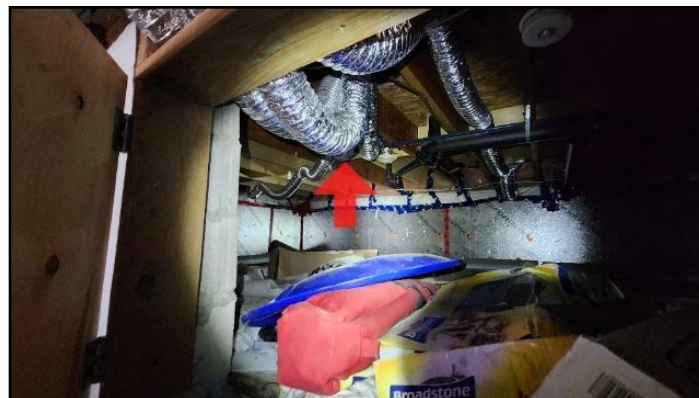
**10. Condition:** • [Excessively long runs, excessive elbows](#)

**Implication(s):** Increased heating costs | Reduced comfort

**Location:** Crawl Space

12. Excessively long runs, excessive elbows

**Task:** Repair

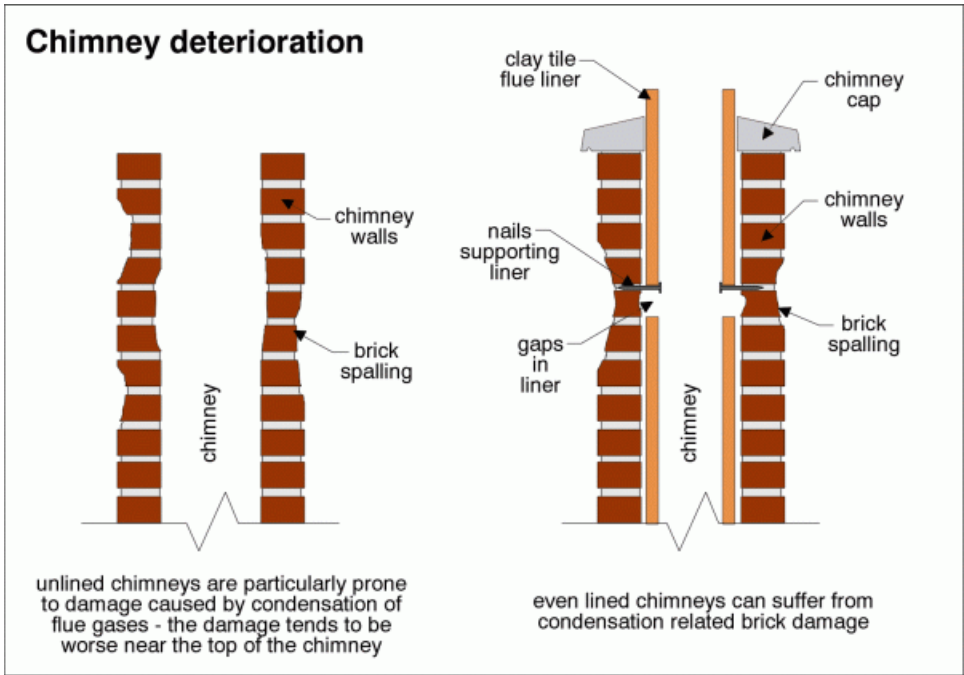
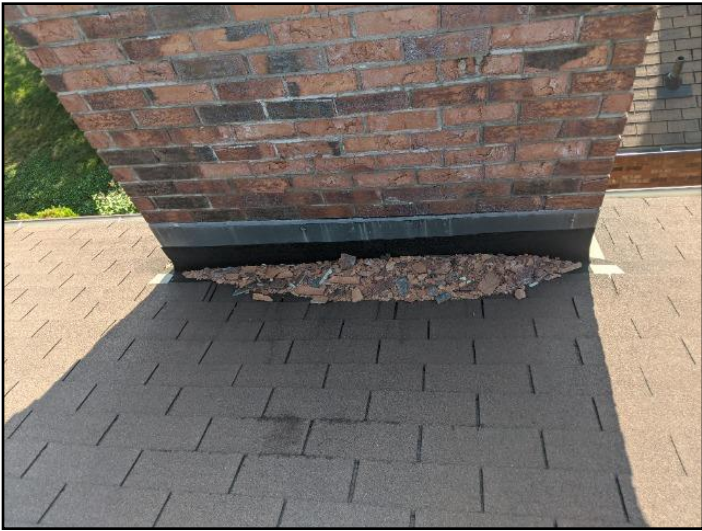
11. Condition: • [Spalling](#)

Implication(s): Material deterioration

Location: Roof

13. Spalling

Task: Repair

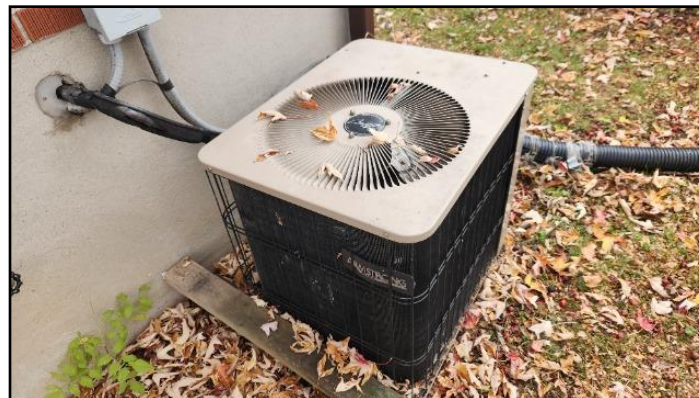
**12. Condition:** • Past life expectancy

AC unit manufactured in 1996, while it functioned during the inspection - you should budget for replacement

**Implication(s):** Equipment failure | Reduced comfort

15. *Past life expectancy*

**Task:** Replace

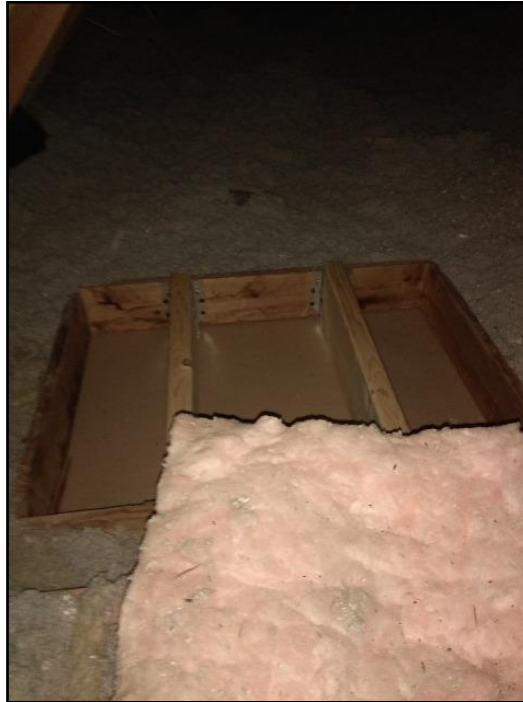
**13. Condition:** • [Gaps or voids](#)

**Implication(s):** Increased heating and cooling costs | Reduced comfort

**Location:** Attic

16. Gaps or voids

**Task:** Correct

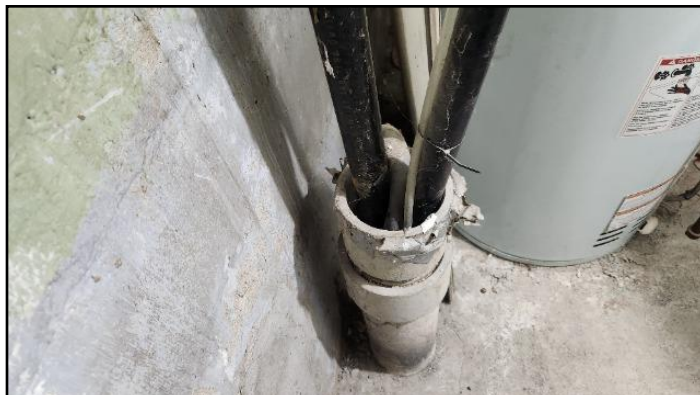
**14. Condition:** • Unprofessional drain installation

**Implication(s):** Improper draining, leaks, sewer gases entering home

**Location:** Basement

17. Unprofessional installation

**Task:** Repair, Evaluation by plumber

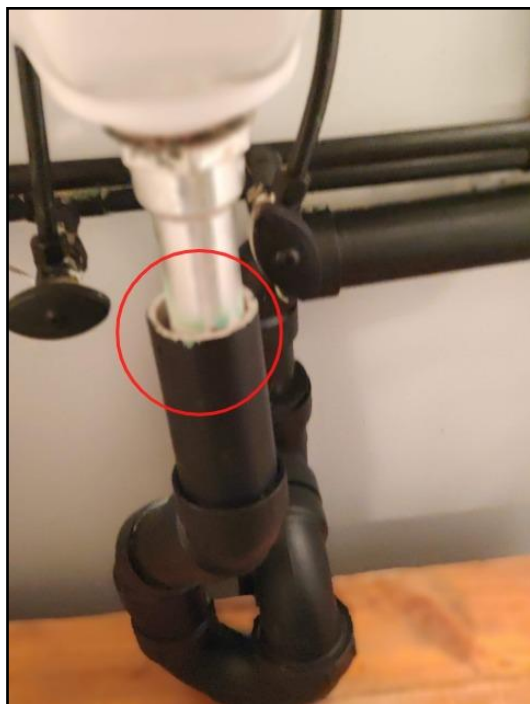
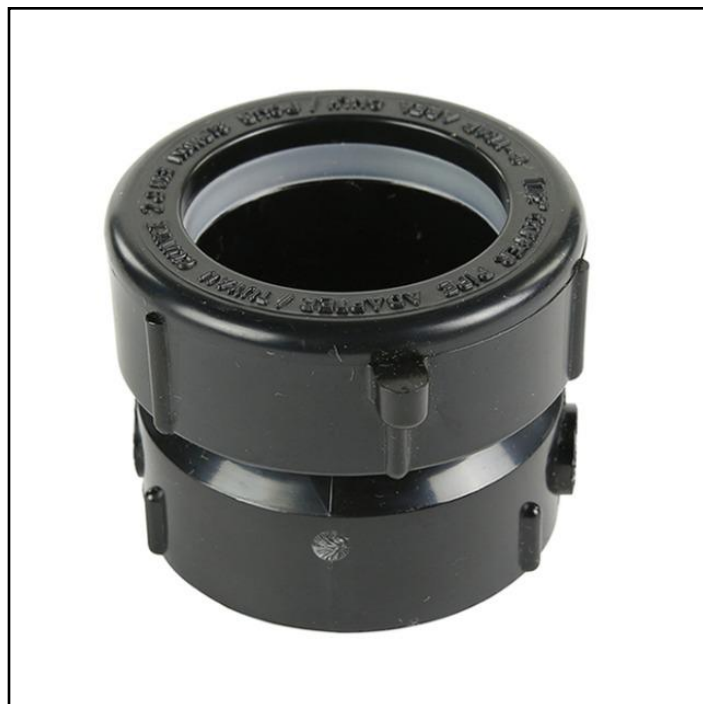
**15. Condition:** • Plumbing drain missing abs adapter

**Implication(s):** Leaks, damage to materials or finishes

**Location:** First Floor Bathroom

18. Missing fitting

19. Missing adapter

**Task:** Correct

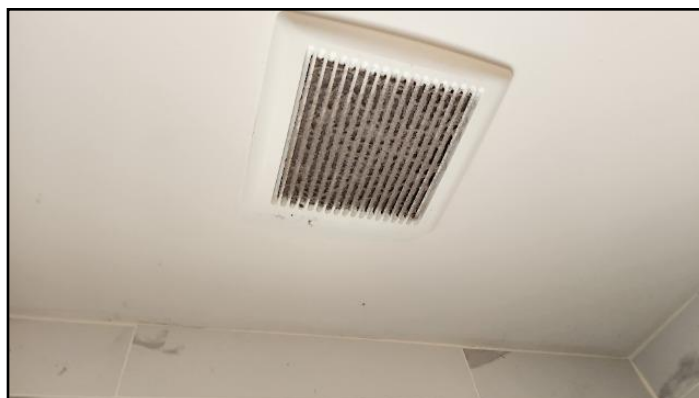
**17. Condition:** • Dirty

**Location:** First Floor Bathroom

21. Dirty

**Task:** Clean
